Lariat Creek: E940 (American Horse Road)

Blue Thumb Volunteer Monitoring Data Interpretation – July 2012

Description of Watershed and Monitoring Site

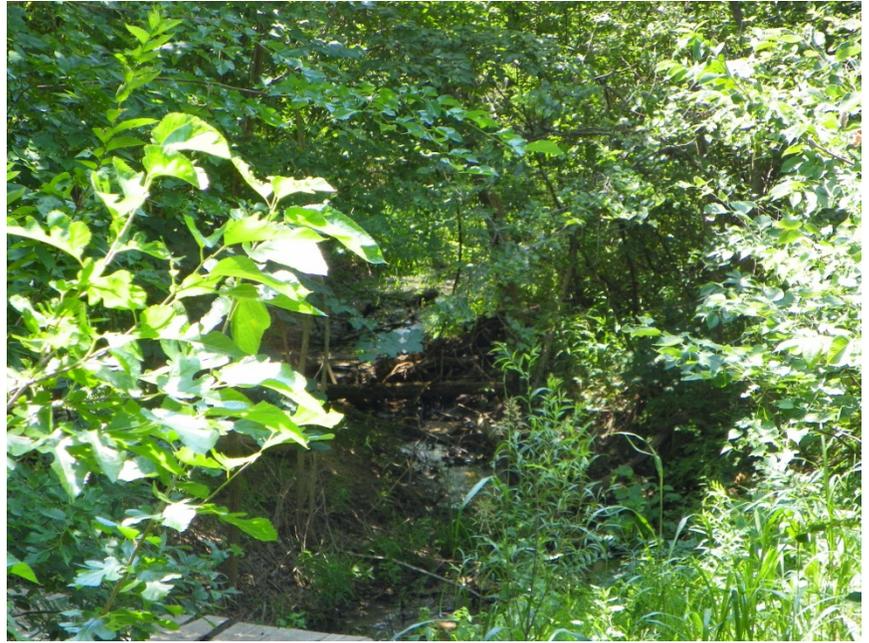
Although a habitat assessment is performed every time a group goes to the creek, the most comprehensive assessment is taken in accordance with a fish collection. On June 18, 2009, the **fish collection/habitat assessment** was performed on Lariat Creek for 400 meters downstream from the monitoring site. The canopy and streamside covers were reported as being of high quality as is illustrated by this photo taken at the Lariat Creek Christian Camp on June 9, 2012. Instream cover and bank vegetation stability were only reported to be of medium quality. However, these variable points were not enough to overcome the poor quality of the rest of the parameters assessed.

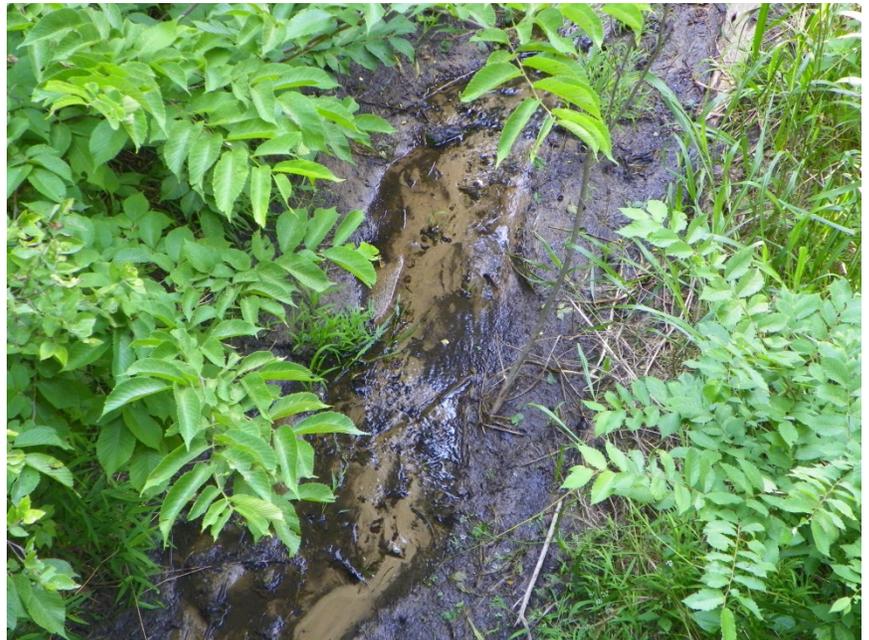
Pool bottom substrate and flow are two parameters illuminated by this second photo. The creek channel is a mixture of sand and silt and clay making it very unstable for both macroinvertebrates and fish. As a spring-fed creek, the flow is chronically low year round with short bursts of water during precipitation events. Spring-fed creeks generally do not dry up during the long, hot summers in Oklahoma. A bit of established bank vegetation can be seen on this photo as well.

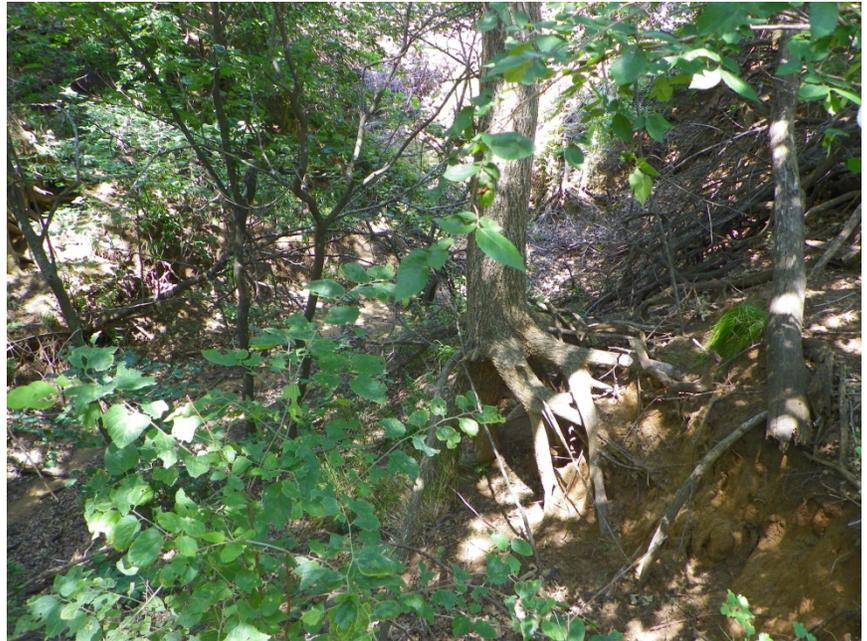
Finally, **bank stability** is of obvious concern based on this third photograph. Although bank vegetation may be considered to be reasonably well established by grasses and small plants, trees

which form the canopy cover, are being undermined by massive erosion. Going forward these issues need to be actively addressed to improve these factors that immediately impact the stream.

Because Lariat Creek is spring-fed it will most likely endure; however, there are some actions that can be taken to improve its condition. An enhancement of bank stability would go a long way to stimulate a recovery in many of the other issues. Fencing out the cattle would help the physical habitat a great deal as well as the water quality.
